SURVEY REPORT

BAYFIELD 32

Prepared for:

GENERAL

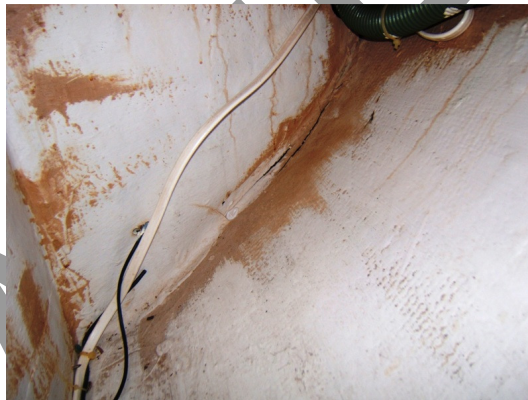
Generally of plywood, sound and secure. Exception – port bulkhead forward, cracked GRP tabbing and lower part of plywood bulkhead a little soft. {2}

{2} Port bulkhead forward, cracked GRP tabbing and lower part of plywood bulkhead a little soft. Not structurally critical at this time but better to repair now than wait.

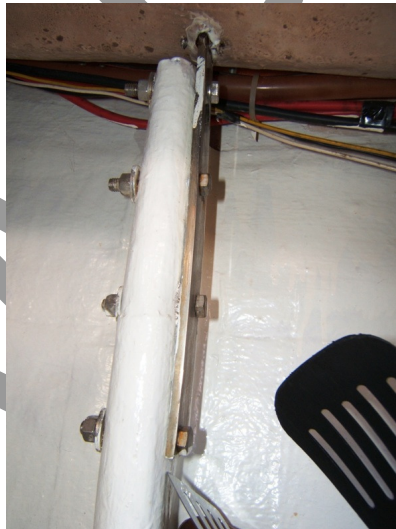
Shroud plates: s/s. GOOD – Note – port side deck penetrations leaking. {4}

{4} Shroud plates: – port side deck penetrations leaking. These should be rebbed to avoid future degradation of structure below deck.

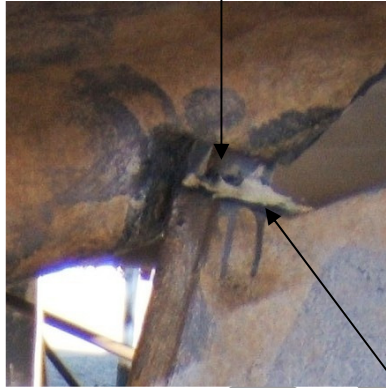
Steering: Edson
 Helm indicator: Marked King spoke.
 Mechanism: Wire and sheaves. GOOD
 Rudder stock(s): s/s. NOTE – a soft metal sleeve visible at outer portion turned with stock. Purpose unclear.

Rudder(s): GRP. FAIR - Penetration of stock into rudder top requires resealing.{6}

{6} Penetration of rudder stock into rudder top requires resealing.
