**SURVEY REPORT** [REDACTED]

**Chaparral 350 Signature**

2022 April 11

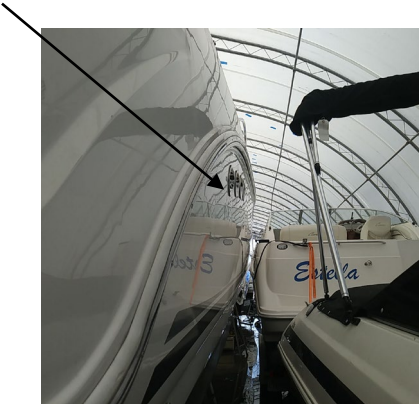
Visually fair except for some rippling at upper aft starboard quarter.

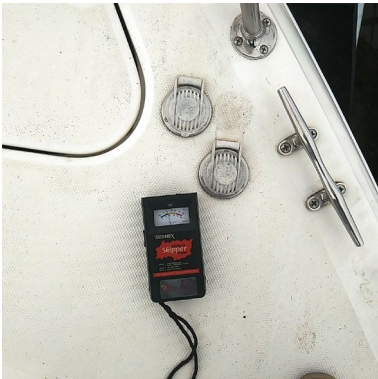
Sound.  
Moisture metered and found to be dry except in way of the windlass foot controls.  
(Meter registered 35 on relative scale 1 – negligible moisture content).

A typical finding on this type and vintage of boat. Insignificant, no immediate action required. Surveyor's Recommendation {1} Client may wish to have moisture rechecked annually if moisture content persists consider removal of deck fittings and windlass and check the seal of deck edges around openings.

{1} Client may wish to have moisture rechecked annually if moisture content persists consider removal of deck fittings and windlass and check the seal of deck edges around openings.

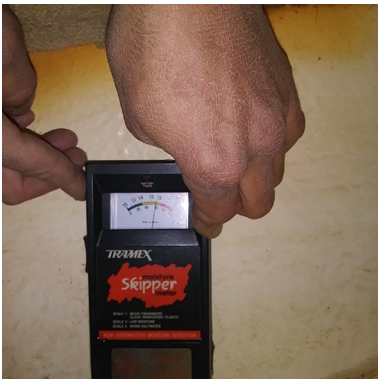
**Floors:** Wood encapsulated in fibreglass. Generally sound and well bonded to hull.  
**Exceptions:**  
Floor on starboard side in the aft cuddy. Registered high moisture in way of a crack in the fibreglass. A piece was pried off to reveal the wood core. The wood appeared sound, resisting a screw driver. {2} The area is localized and unlikely to cause any issues for a considerable time. However, it would be prudent to remove the loose fibreglass, allow the wood to dry, then re-glass.

High moisture in way of loose fibreglass

{2} The minor deterioration of the structure in way of the aft cuddy berth is localized and unlikely to cause any issues for a considerable time. However, it would be prudent to remove the loose fiberglass, allow the wood to dry, then re-glass.
