SURVEY REPORT

ONTARIO 32

Prepared by:
SWL CONSULTANTS
Kemptville, Ontario
tel: 613-258-9953

2022 May 11

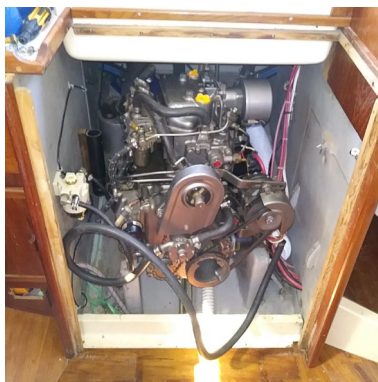
Engine model: Yanmar 20hp. Rebuilt seven years ago.
Model #: 2QM20

Condition:		GOOD
Operation: start	Winterized therefore not started.	
Engine seats:	Resilient mounts lag bolted onto engine beds.	GOOD
Propeller:	Three bladed, bronze, 14RH14.	GOOD
Shafting:	1" s/s.	GOOD
Coupling:	Flanged with intermediate flex.	GOOD
Shaft inner bearings:	None	
Shaft stern tube bearing:		GOOD
Struts & bearings:		GOOD

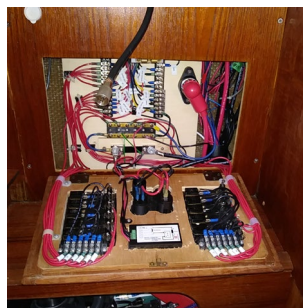
Panel: { TP1332 – 8.10}	Rewired.	VERY GOOD
-------------------------	----------	-----------
