SURVEY REPORT

ONTARIO 32

Prepared by:
SWL CONSULTANTS
Kemptville, Ontario
tel: 613-258-9953

2022 May 11

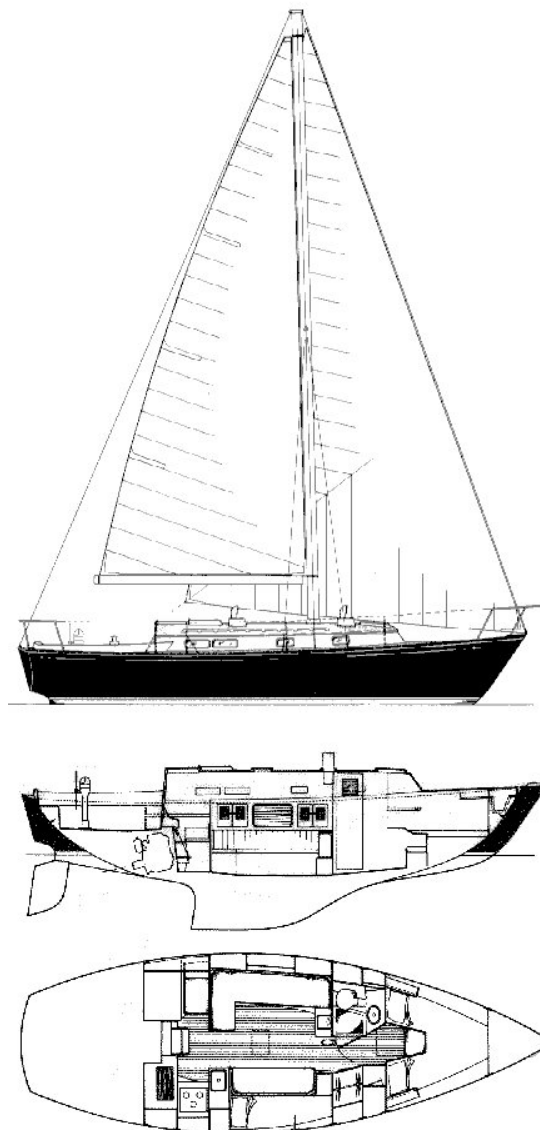
VESSEL DESCRIPTION

Vessel is a stock production cruiser sloop rigged sailboat.
Hull form, round bilged light displacement with ballast fin keel.
Flush decked with raised cabin trunk and self-draining aft cockpit.
